Test Report

| _ | |
|---|---|
| Report No | 2370/7934011 |
| Items tested | 3 off PVC-U windows, Veka Internally Glazed Casement Window Systems |
| Specification | BS EN 14351: 2006 Windows and doors – Product standard, performance characteristics Part1: Windows and external pedestrian doorsets without resistance to fire and/or smoke leakage characteristics Clause 4.8 load bearing capacity of safety devices. BS EN 14609: 2004 Windows – Determination of the resistance to static torsion |

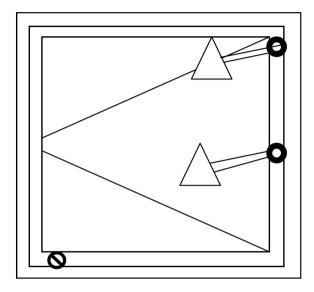
SUMMARY OF RESULTS (Sample 3)

- The test specimen was opened and closed 5 times before test, then opened to engage restrictors ready for the 350N force to be applied.
- A 500N was applied to the centre of the sash, next to the handle and the top of the sash
- Position of eyebolt attachment •
- Position of restrictor **O**
 - Direction of load labelled by arrow
 - Window had no permanent damage after test and restrictor did not fail. **Pass**
